**Inspection Report
for
Rainey Ranch
1035 Horse Creek Rd.
Horse Creek, CA, 96050
41.8254° N, 123.0035° W**

Inspection Narrative

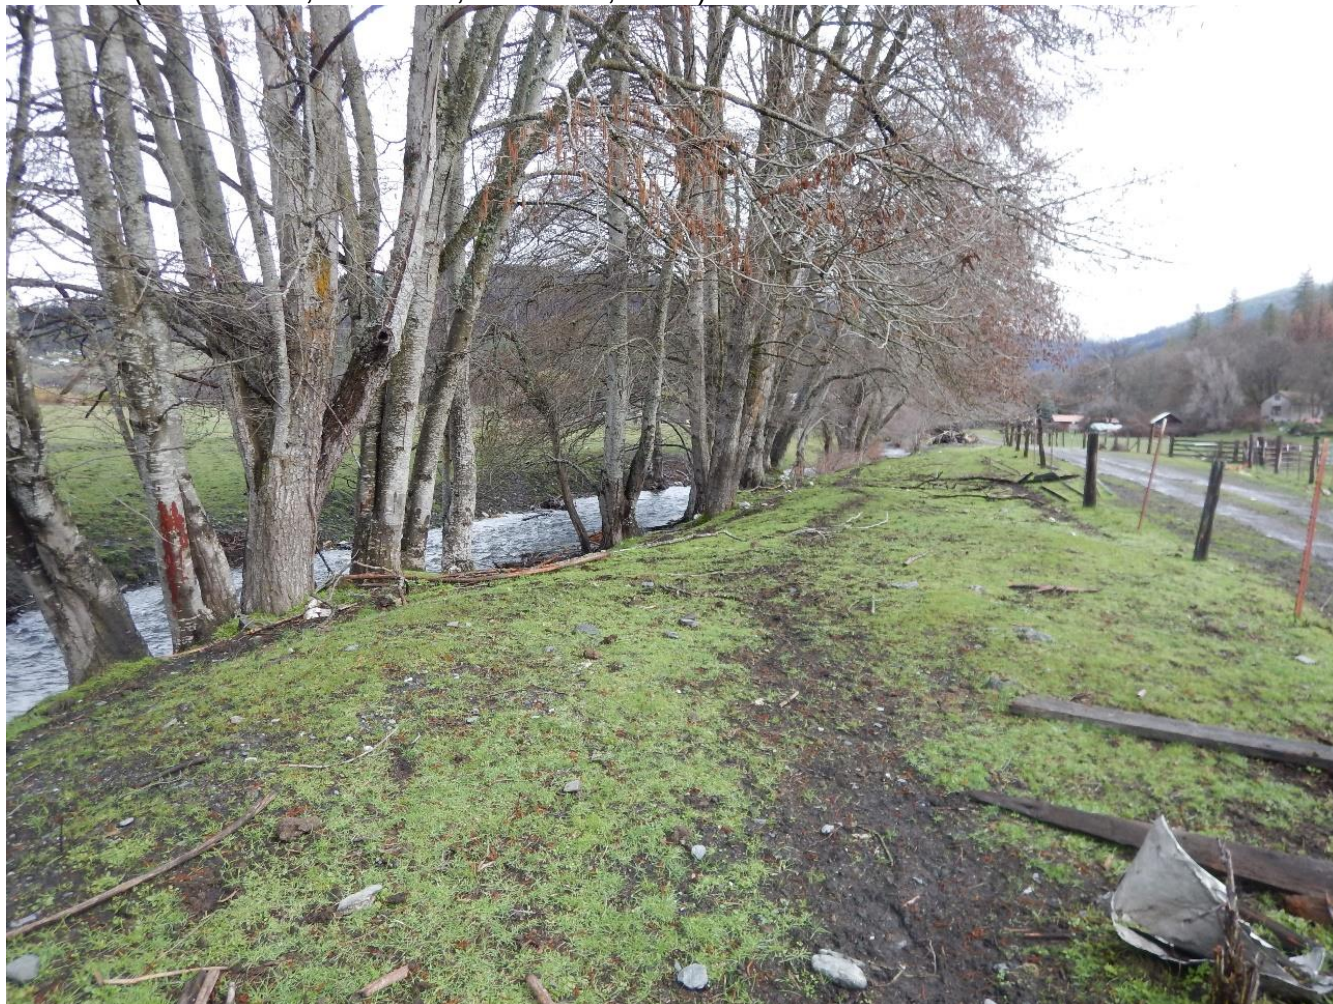
Photo 1 (J. Shannon, 9:16 a.m., March 27, 2019)

At Site 1, livestock (cattle and horses) have unrestricted access to approximately 700 feet of Buckhorn Creek as it runs through an approximately 4.25-acre pasture. At the time of the inspection, the streambanks were lightly vegetated with grasses and did not appear to be actively eroding but were trampled and appeared to be regularly trafficked by livestock. The site has adequate mature riparian trees but lacks riparian understory vegetation to stabilize the streambanks. See photo 1 and photo 2.

Site 1: Southeast bank (river left) of Buckhorn Creek.

Several management practices were discussed that would reduce the extent of livestock-induced impacts to Buckhorn Creek, including livestock exclusion fencing and off-channel water sources and shade structures.

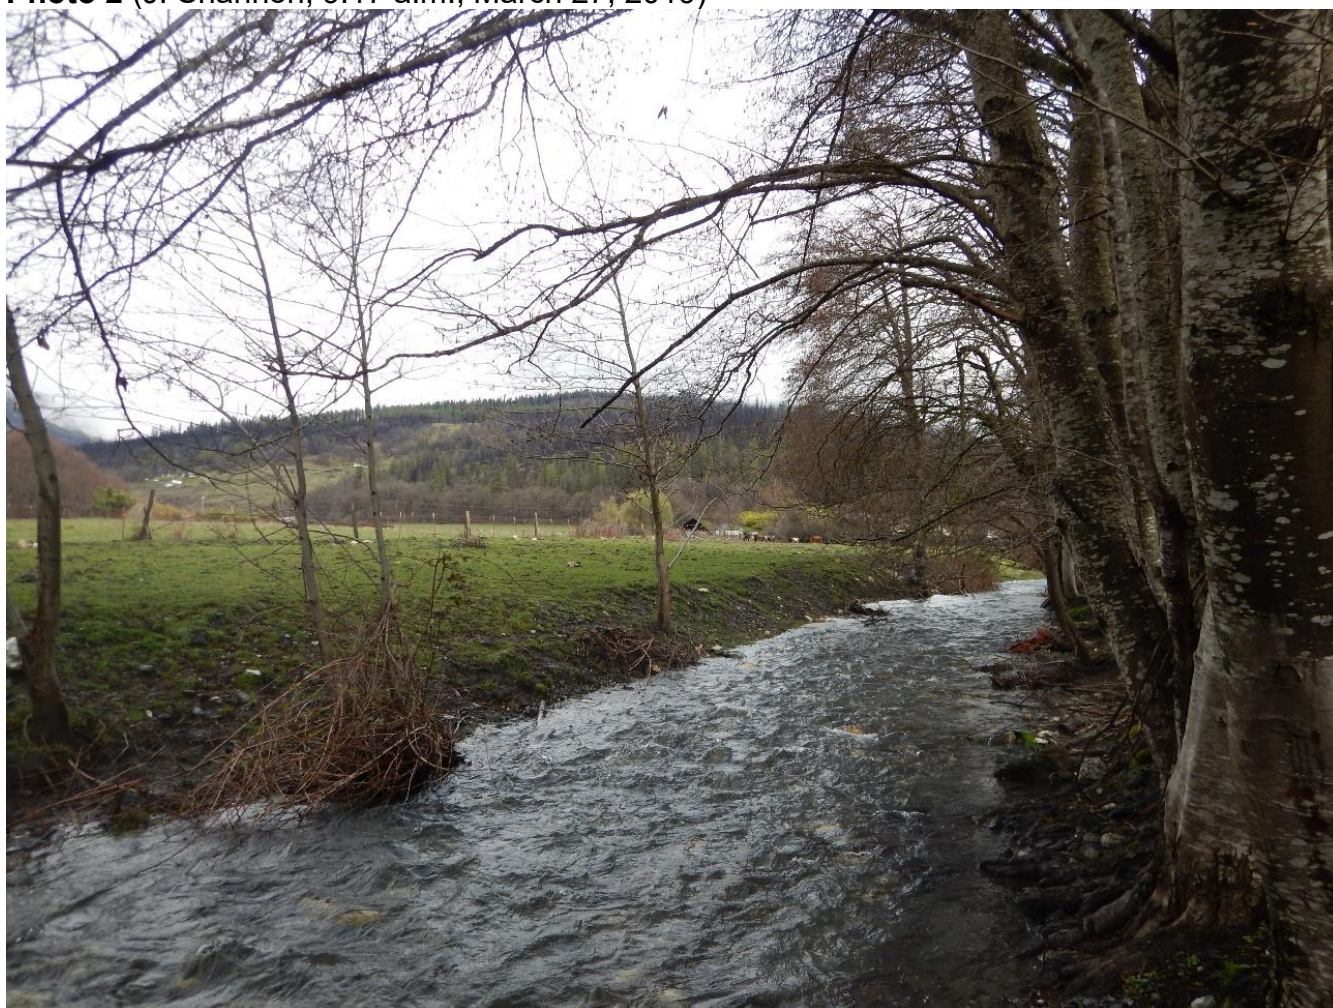
Photo 2 (J. Shannon, 9:17 a.m., March 27, 2019)

Site 1: Northwest bank (river right) of Buckhorn Creek.

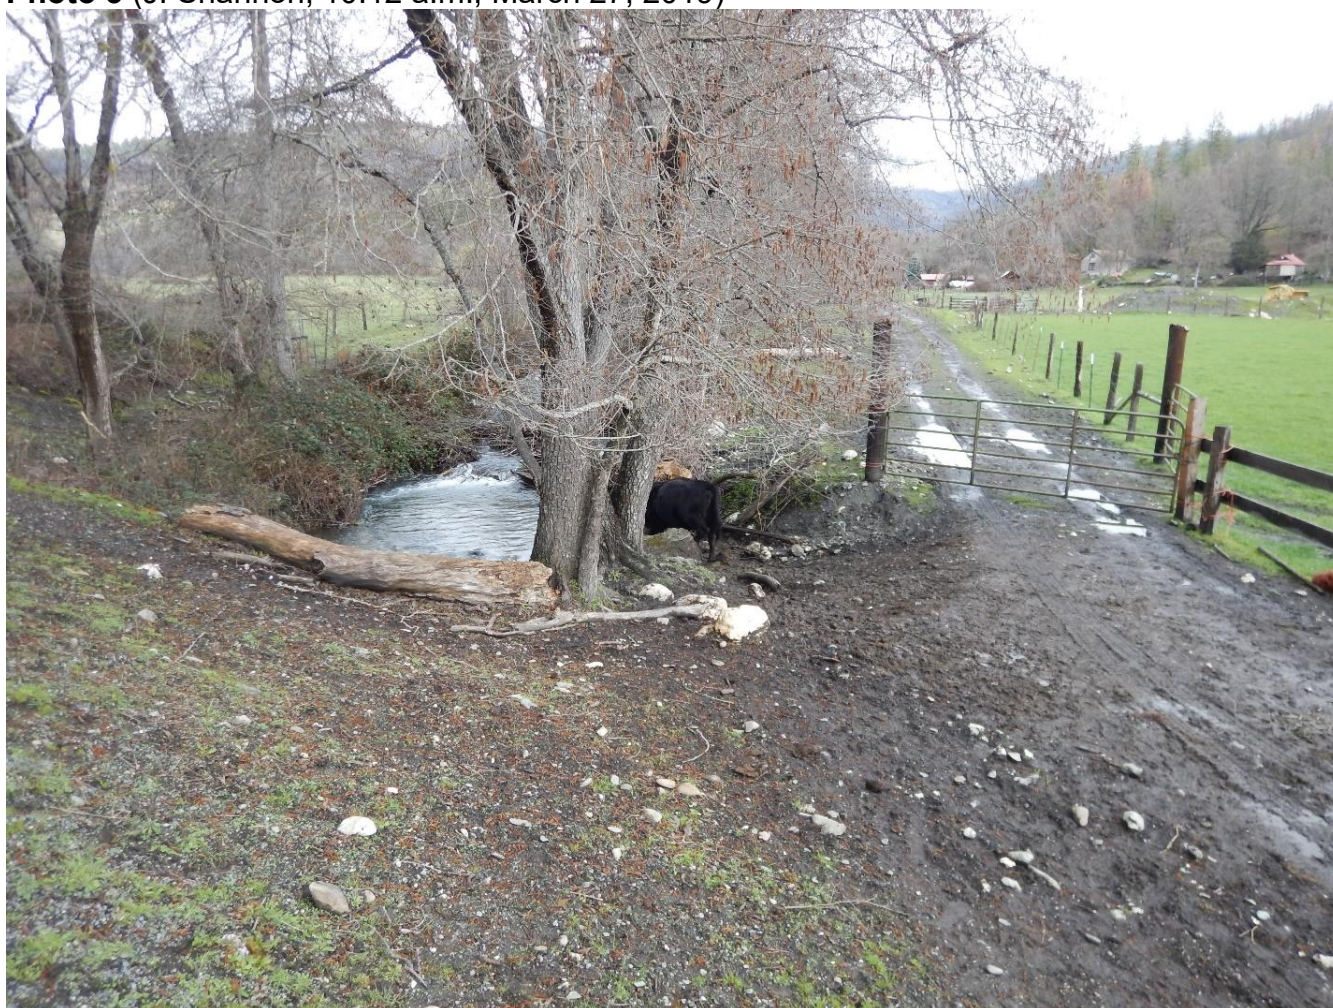
Photo 3 (J. Shannon, 10:12 a.m., March 27, 2019)

Site 2 is an unimproved cattle crossing/watering area located on Buckhorn Creek immediately upstream of Bar Road. The streambanks at the crossing are unvegetated and actively eroding. See photo 3.

Site 2: Cattle crossing/watering area on Buckhorn creek

Several improvements to the cattle crossing/watering area were discussed while at the site. Creating a more defined crossing location, armoring the banks of the crossing location, and laying the streambanks back to a gentler slope could all alleviate the water quality impacts associated with the site.

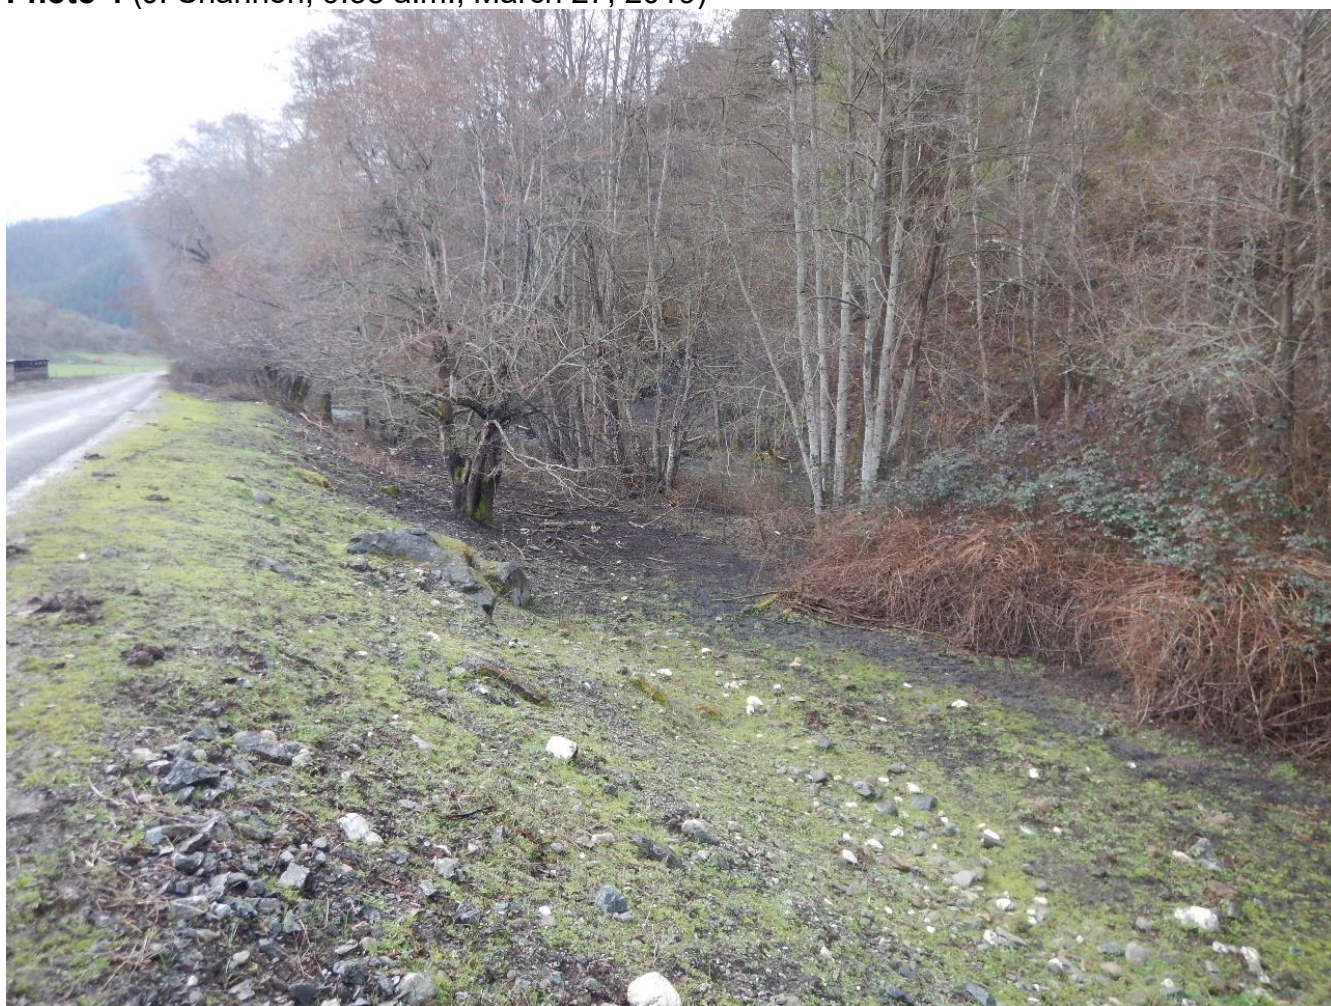
Photo 4 (J. Shannon, 9:35 a.m., March 27, 2019)

At Sites 3a, 3b, and 3c, the streambanks and floodplain terraces are trampled, unvegetated, and severely degraded. Cattle bed-down and loaf within the riparian corridor immediately adjacent to Horse Creek. Within the three sites, all native riparian vegetation has been browsed to non-existence and only invasive Himalayan blackberry remain and substantial cattle-induced erosion is occurring. The sites actively discharge sediment and excess manure to Horse Creek. See photos 4 through 8.

Site 3a: Northern-most cattle bed-down area within the riparian corridor of Horse Creek

Livestock exclusion fencing was discussed as a possible solution to address the water quality impacts at the sites. Currently, a five-strand wire fence runs through the riparian corridor of Horse Creek; however, it is in disrepair because standing dead trees from the Gap Fire of 2016 continually fall on the fence. Livestock exclusion fencing would be most effective if it were located on either the east side of Bar Road.

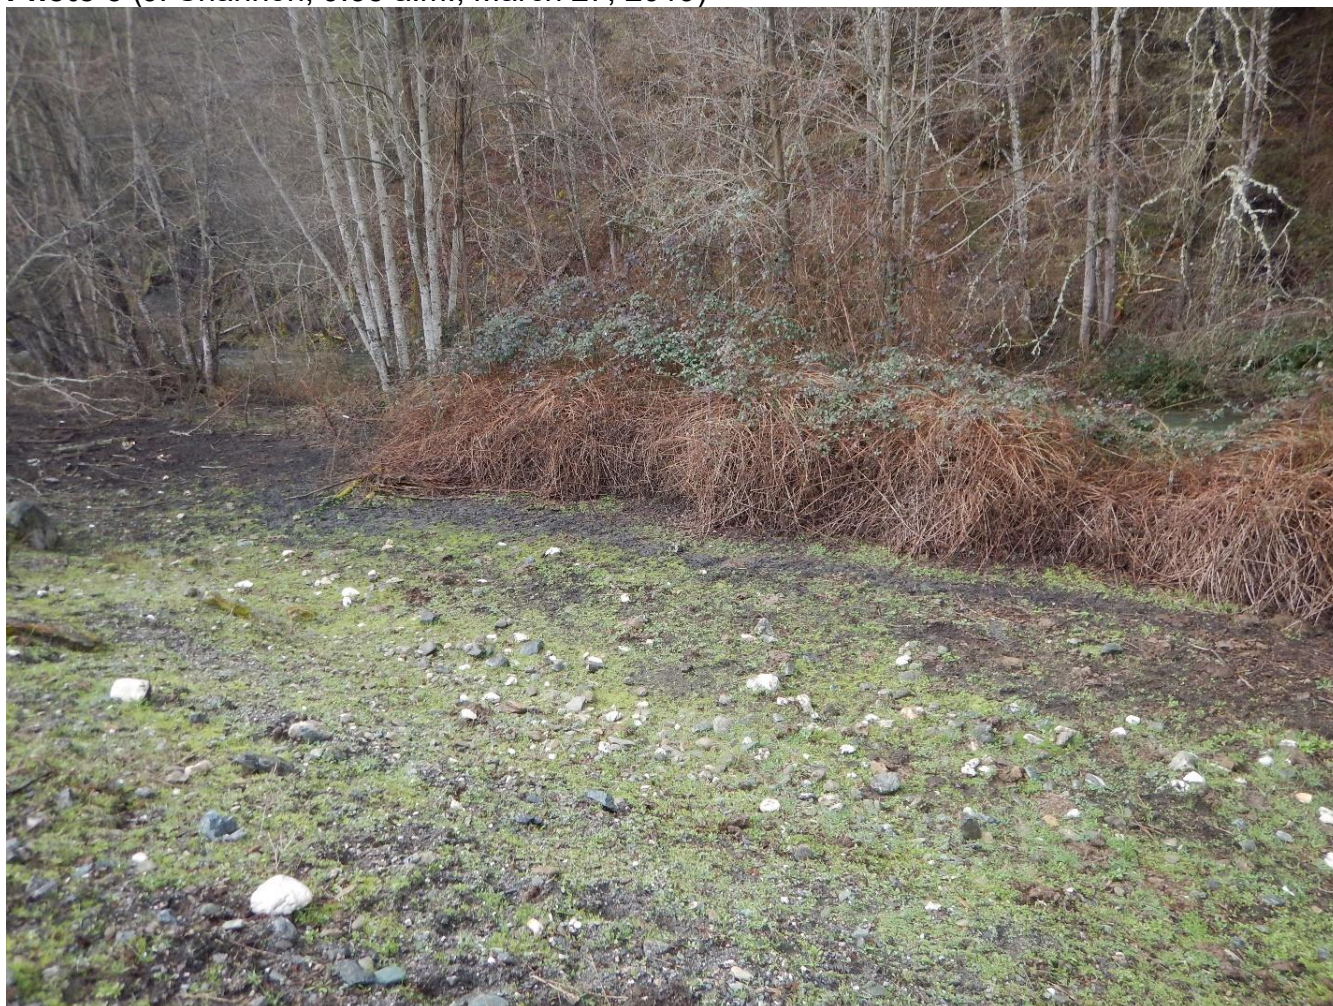
Photo 5 (J. Shannon, 9:35 a.m., March 27, 2019)

Site 3a: Northern-most cattle bed-down area within the riparian corridor of Horse Creek

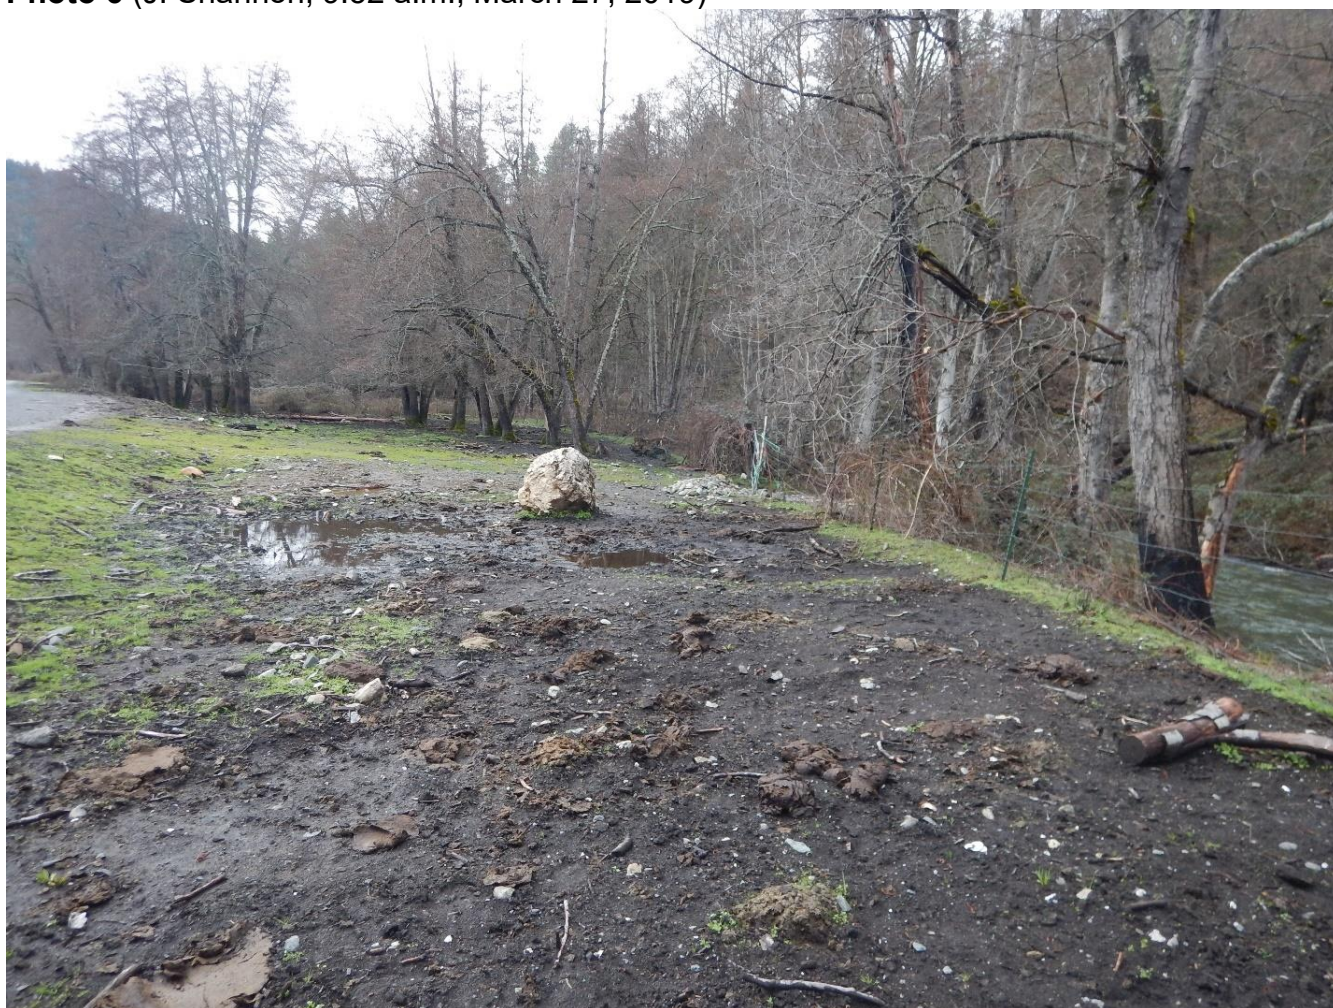
Photo 6 (J. Shannon, 9:52 a.m., March 27, 2019)

Site 3b: Middle cattle bed-down area within the riparian corridor of Horse Creek

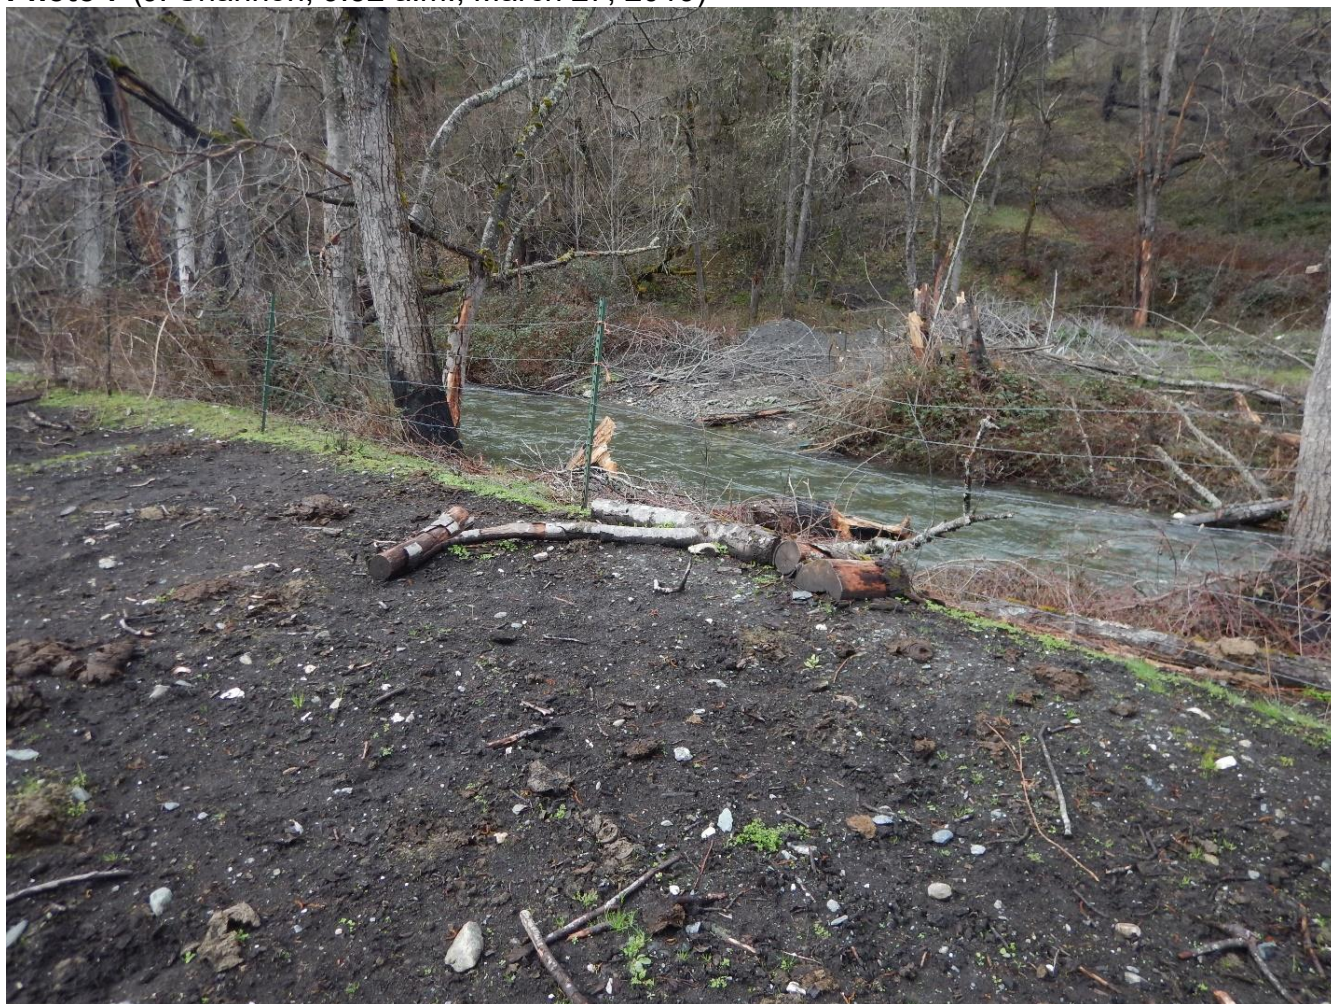
Photo 7 (J. Shannon, 9:52 a.m., March 27, 2019)

Site 3b: Middle cattle bed-down area within the riparian corridor of Horse Creek

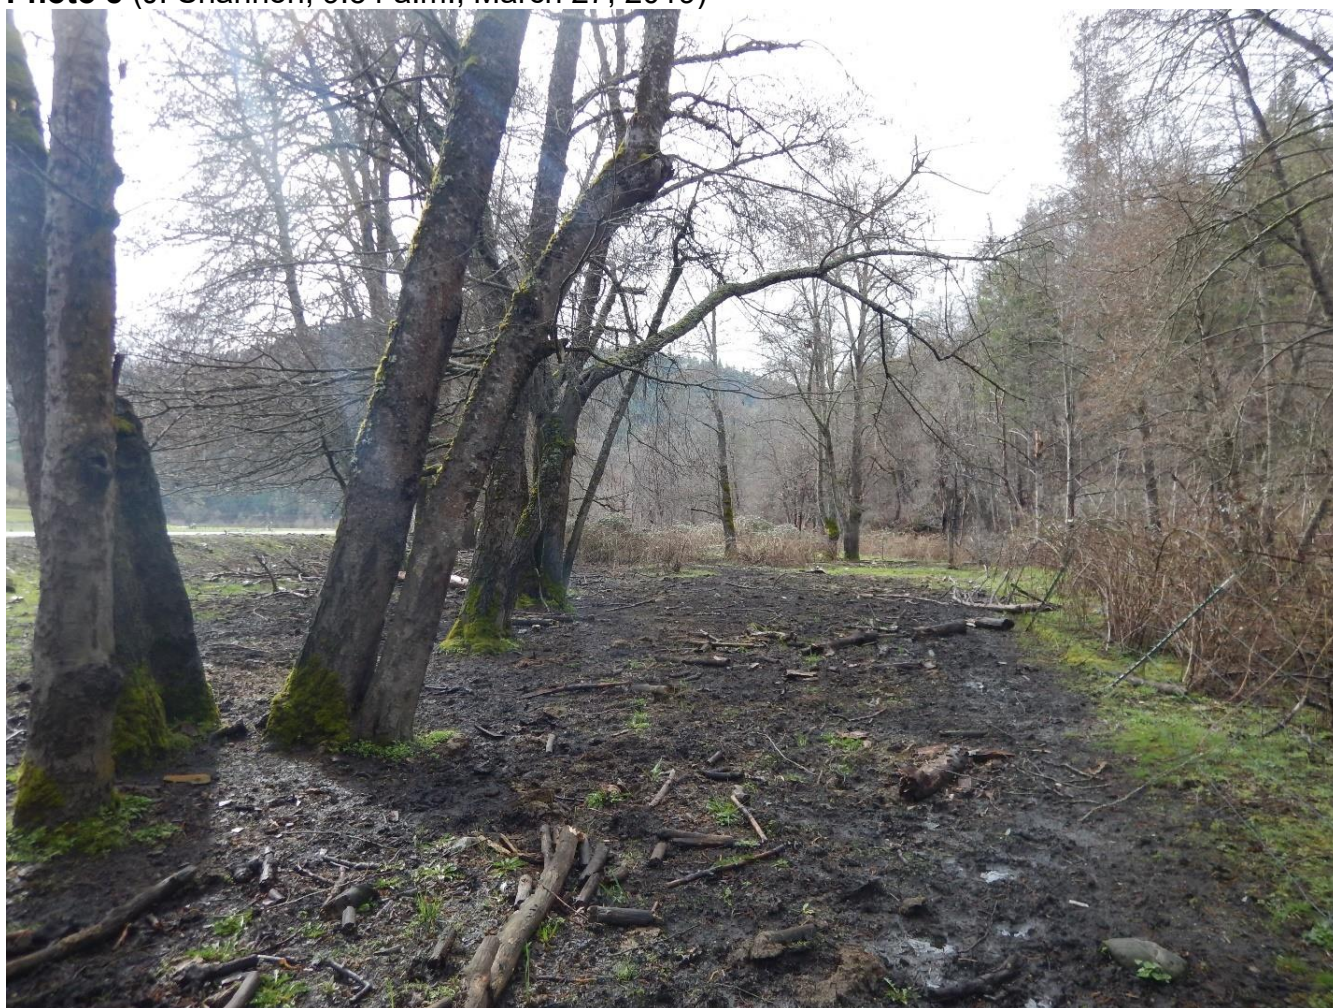
Photo 8 (J. Shannon, 9:54 a.m., March 27, 2019)

Site 3c: Southern-most cattle bed-down areas within the riparian corridor of Horse Creek

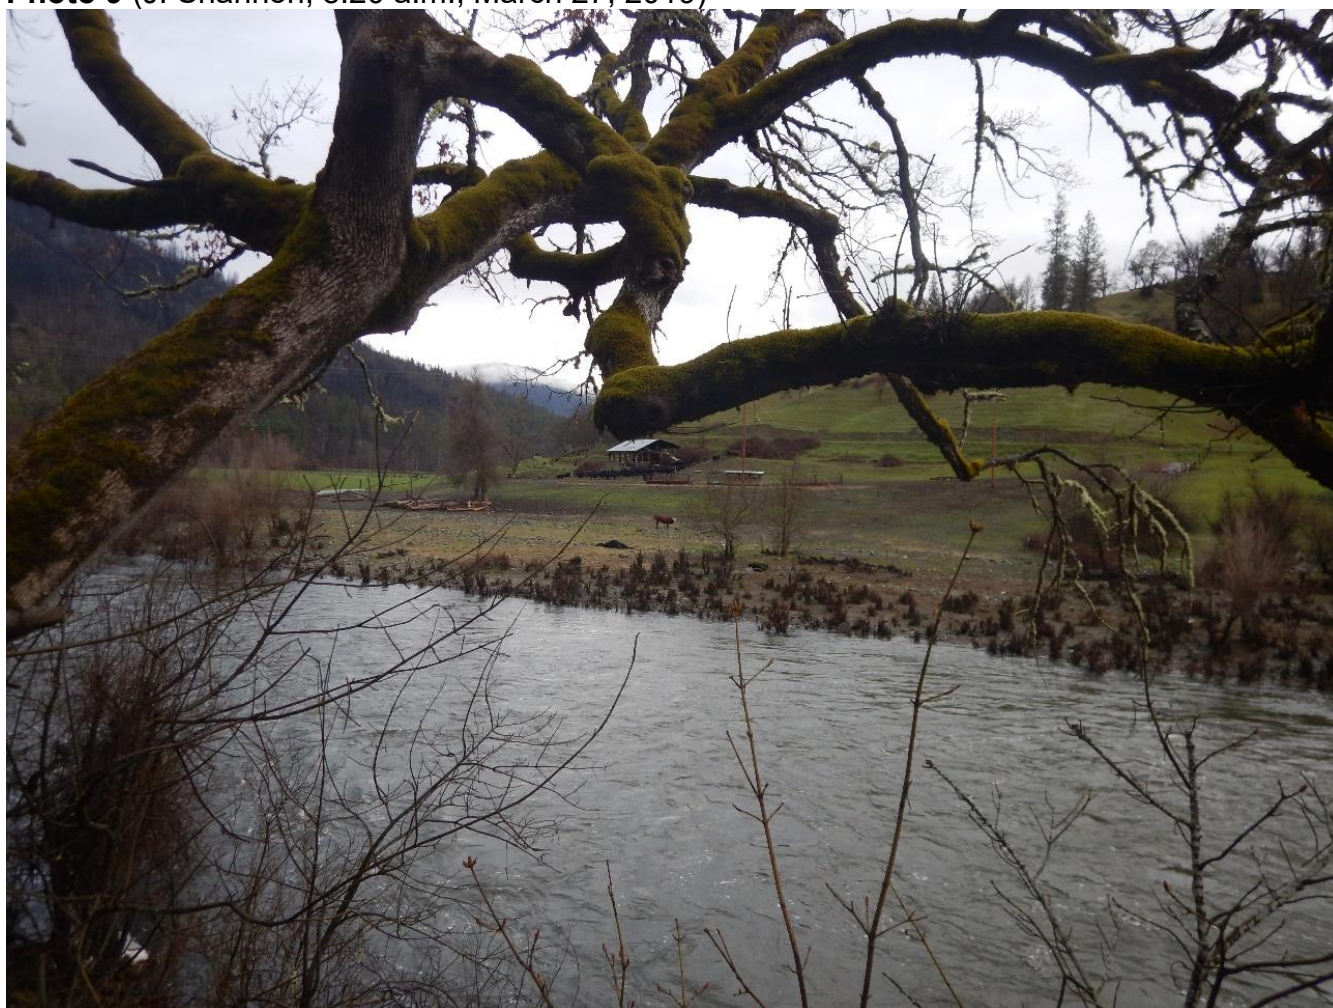
Photo 9 (J. Shannon, 8:20 a.m., March 27, 2019)

Site 4 is an approximately seven-acre pasture that, during the inspection, the Landowner said is primarily used as a feeding lot and that cattle are typically on the site from January through April. The pasture is within the Klamath River's floodplain and is sloped such that anything deposited, manure, exposed sediment, or other, is conveyed to the Klamath River. Additionally, cattle have unrestricted access to approximately 1,500 feet of river frontage. There is no vegetative buffer separating the feeding lot from the river and the riparian vegetation that is present is severely degraded. The site actively discharges sediment and excess manure to the Klamath River. See photos 9 through 15.

Site 4: Pasture adjacent to the Klamath River used as a feeding lot

Several management practices were discussed while at the site, including livestock exclusion fencing and other structures to deter cattle from entering the streamside zone; an earthen berm to intercept run-off; and off-channel water sources, feeding locations, and shade structures further up slope.

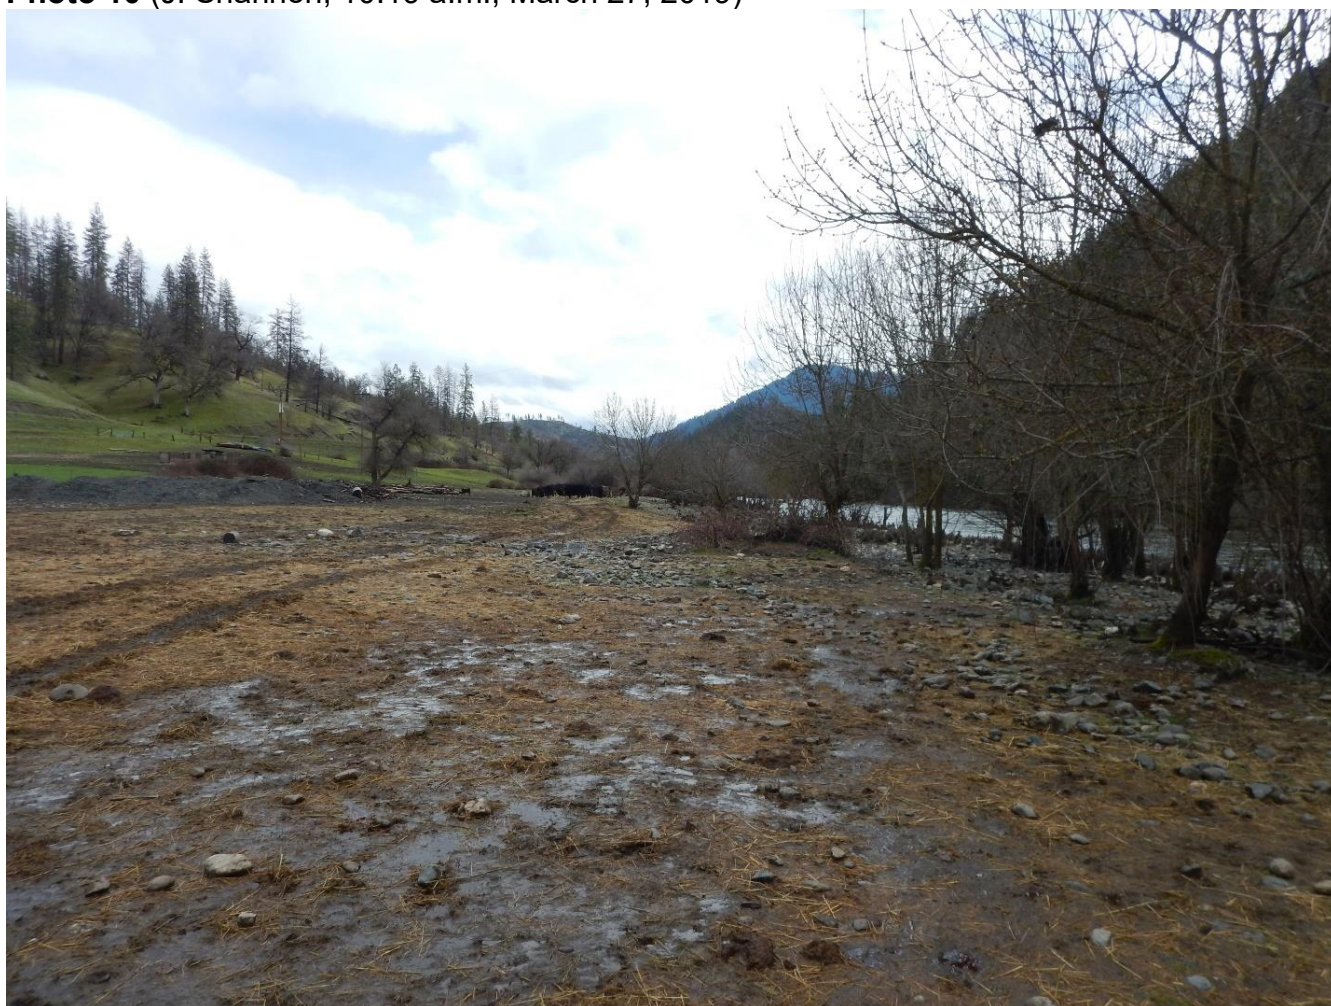
Photo 10 (J. Shannon, 10:19 a.m., March 27, 2019)

Site 4: Pasture adjacent to the Klamath River used as a feeding lot

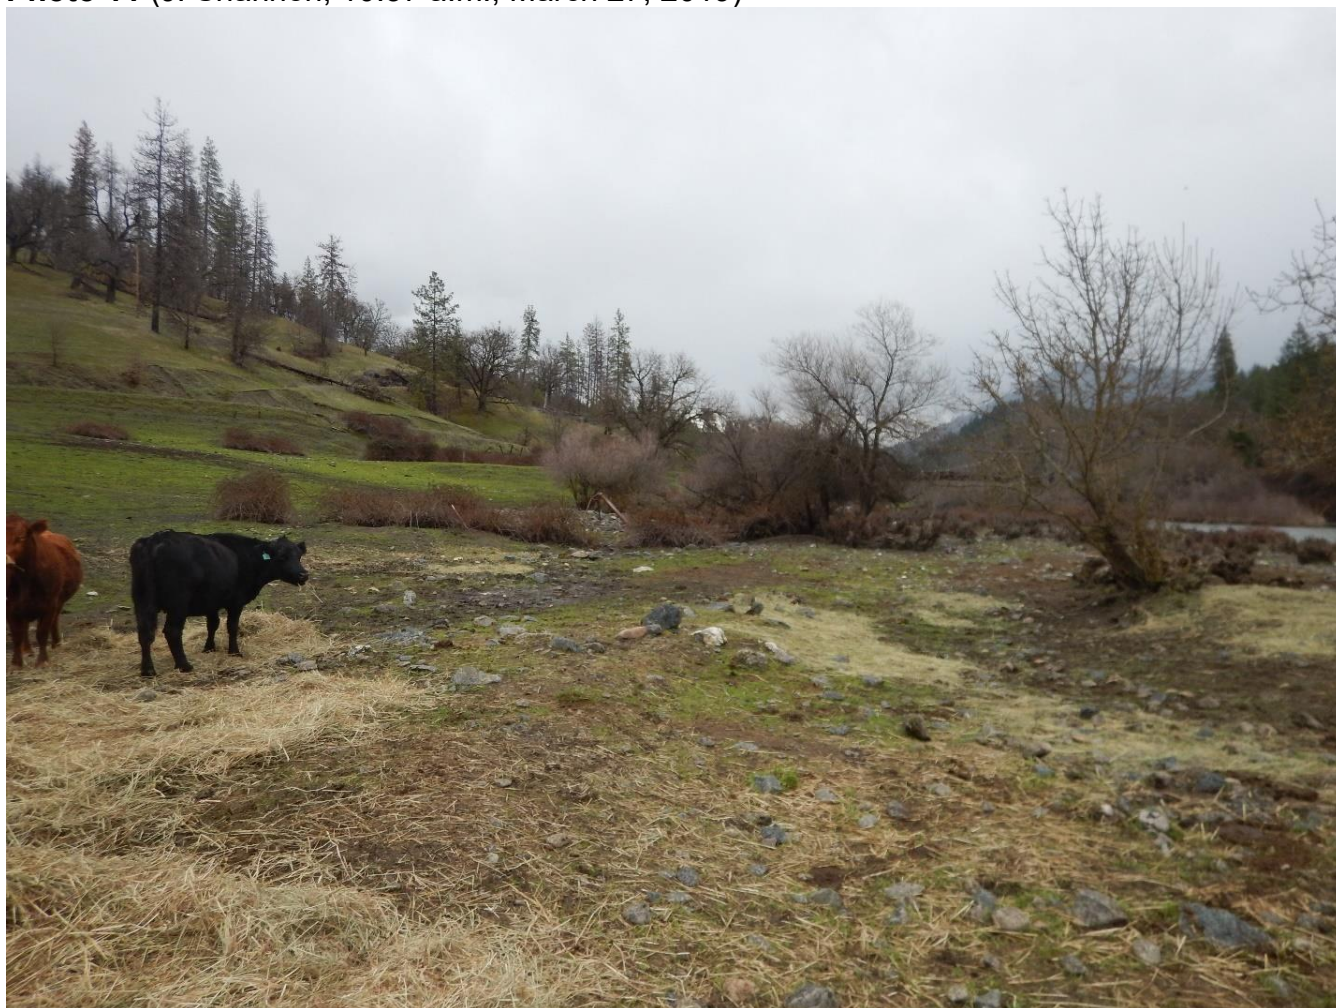
Photo 11 (J. Shannon, 10:37 a.m., March 27, 2019)

Site 4: Pasture adjacent to the Klamath River used as a feeding lot

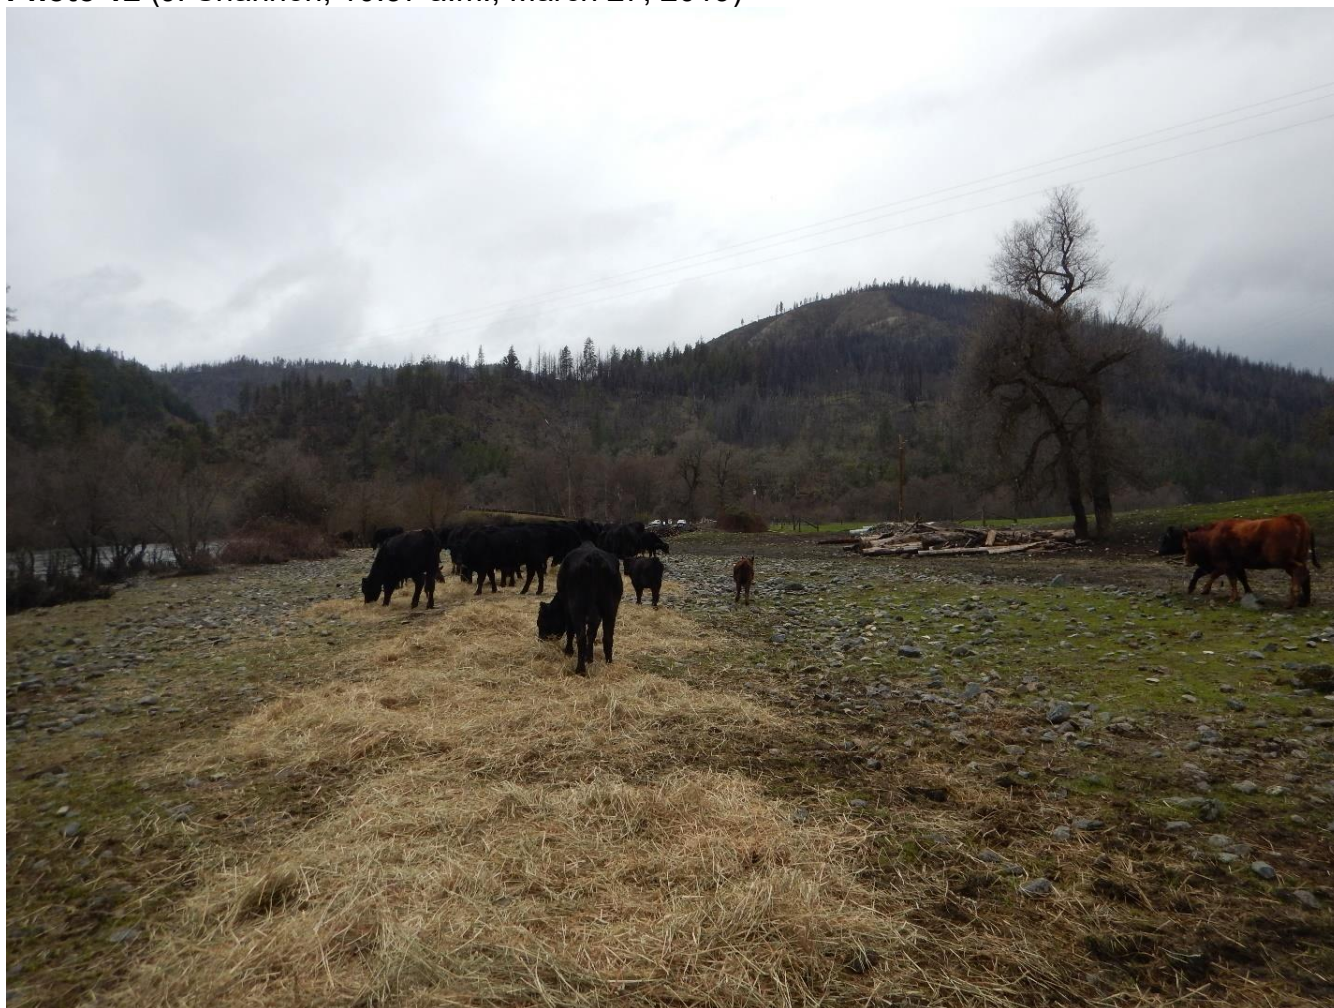
Photo 12 (J. Shannon, 10:37 a.m., March 27, 2019)

Site 4: Pasture adjacent to the Klamath River used as a feeding lot

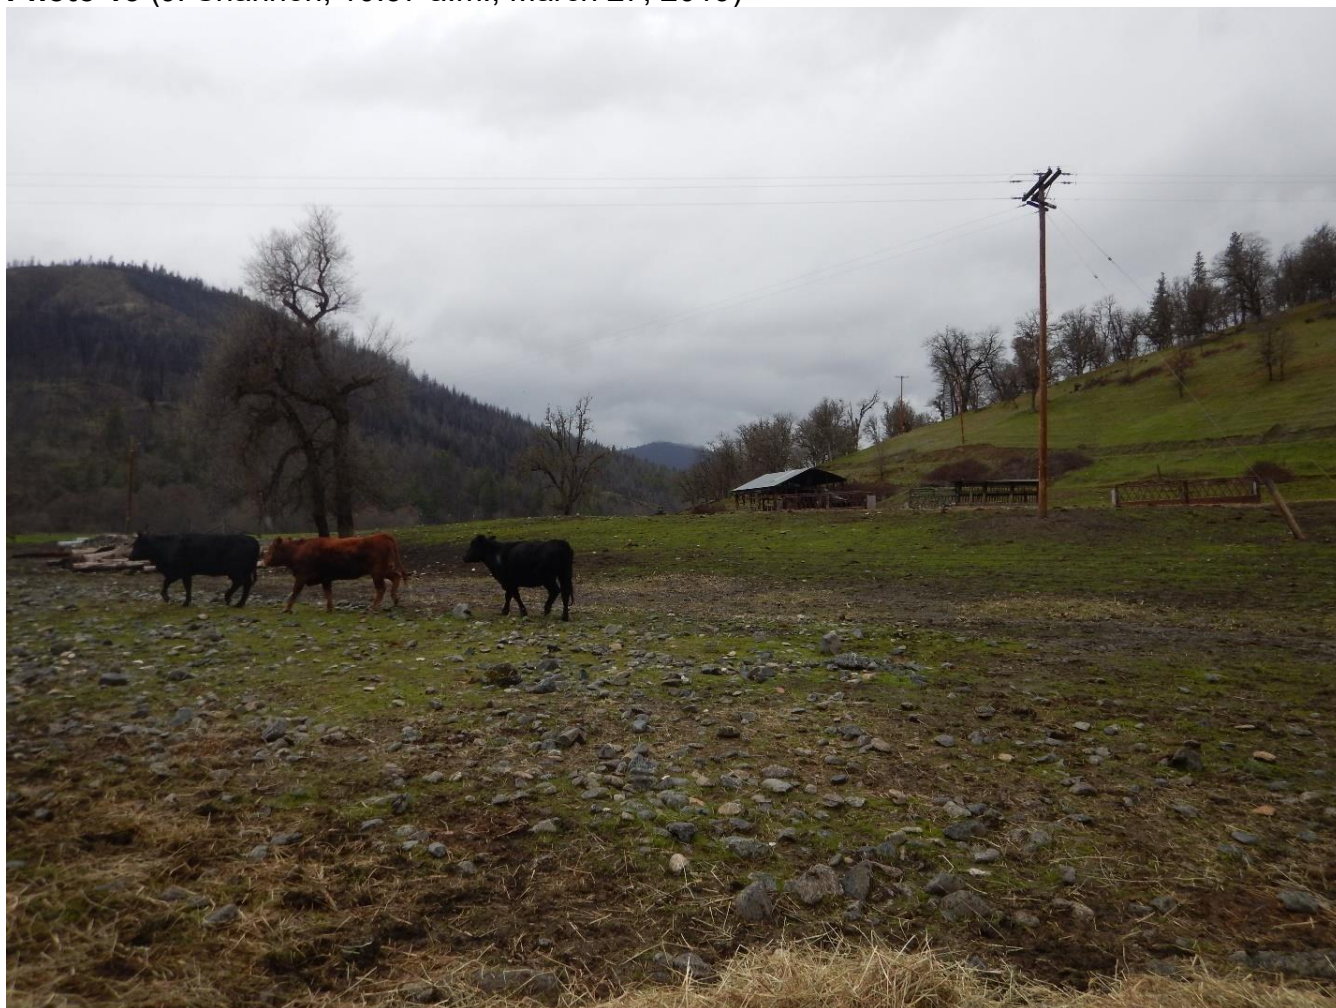
Photo 13 (J. Shannon, 10:37 a.m., March 27, 2019)

Site 4: Pasture adjacent to the Klamath River used as a feeding lot

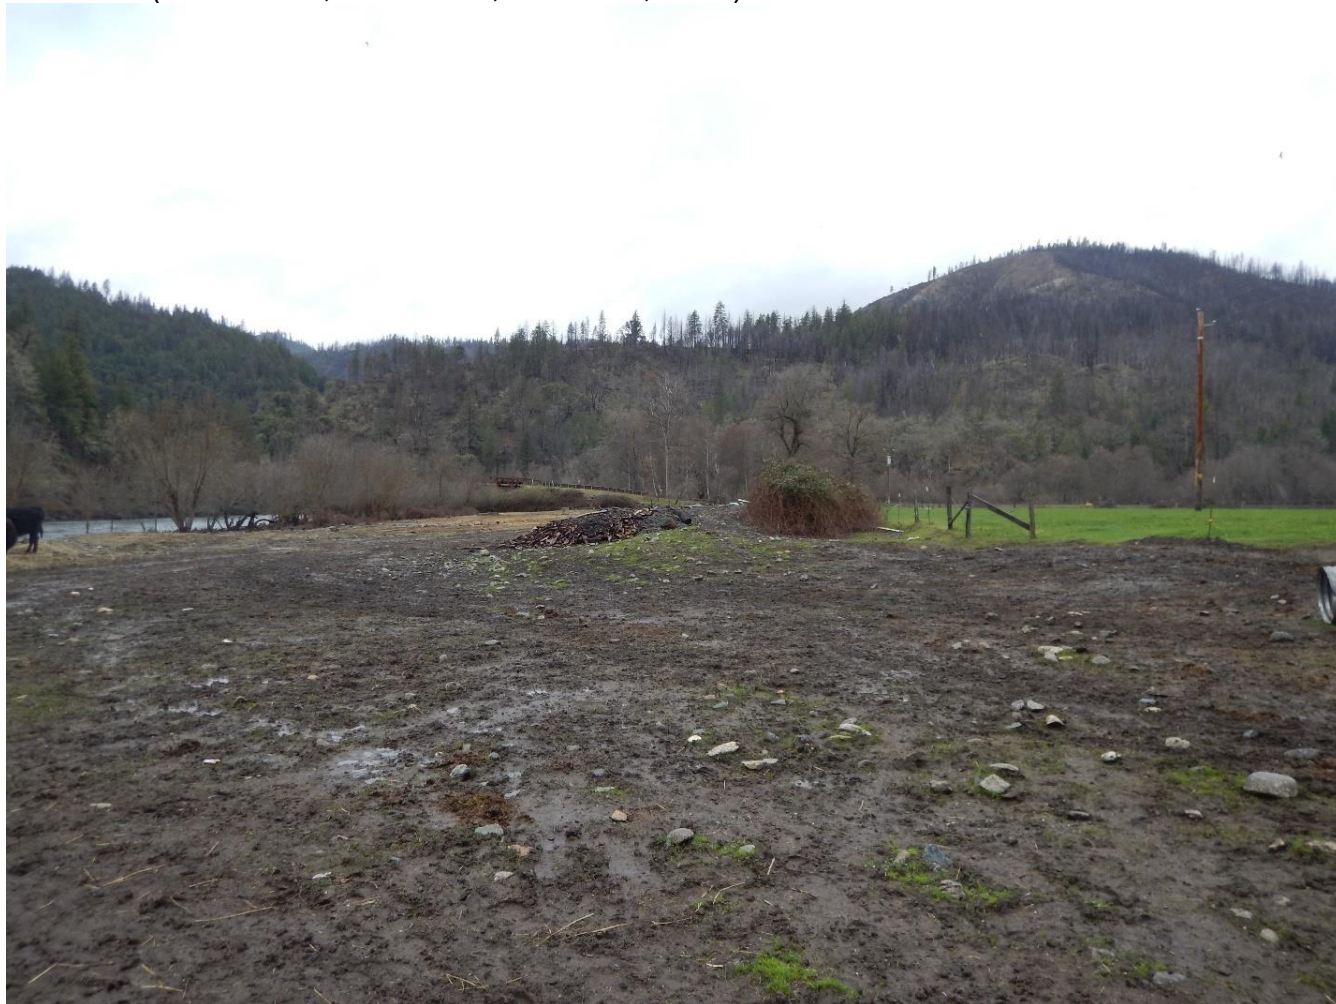
Photo 14 (J. Shannon, 10:39 a.m., March 27, 2019)

Site 4: Pasture adjacent to the Klamath River used as a feeding lot

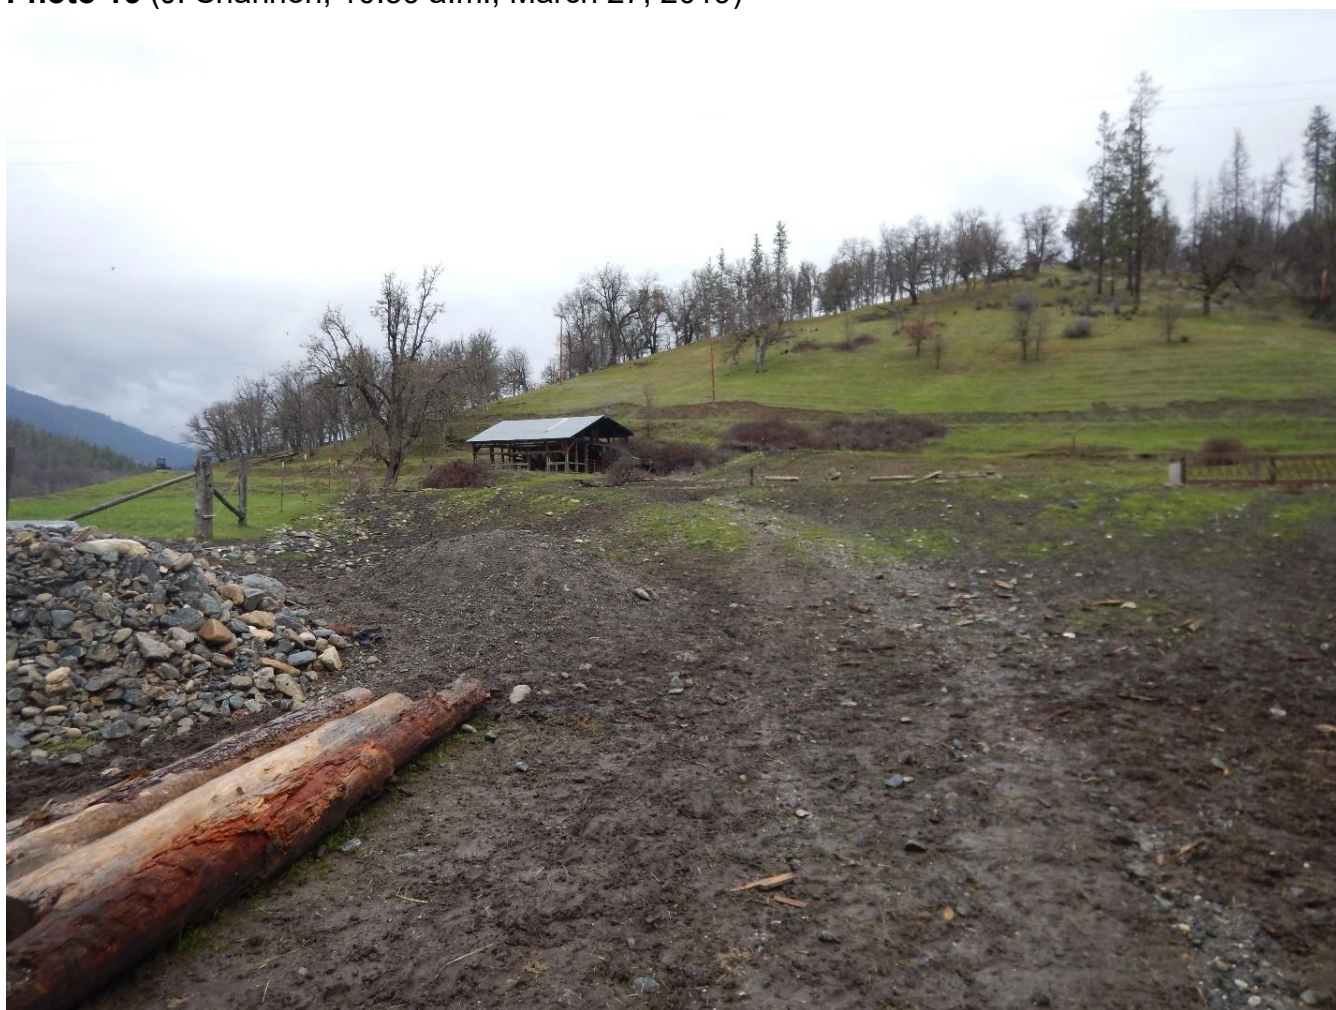
Photo 15 (J. Shannon, 10:39 a.m., March 27, 2019)

Site 4: Pasture adjacent to the Klamath River used as a feeding lot
